Engineered Polymer Composites Through Electrospun Nanofiber Coating of Fiber Tows

Composite materials offer significant weight savings in many aerospace applications. The toughness of the interface of fibers crossing at different angles often determines failure of composite components. A method for toughening the interface in fabric and filament wound components using directly electrospun thermoplastic nanofiber on carbon fiber tow is presented. The method was first demonstrated with limited trials, and then was scaled up to a continuous lab scale process. Filament wound tubes were fabricated and tested using unmodified baseline towpreg material and nanofiber coated towpreg.

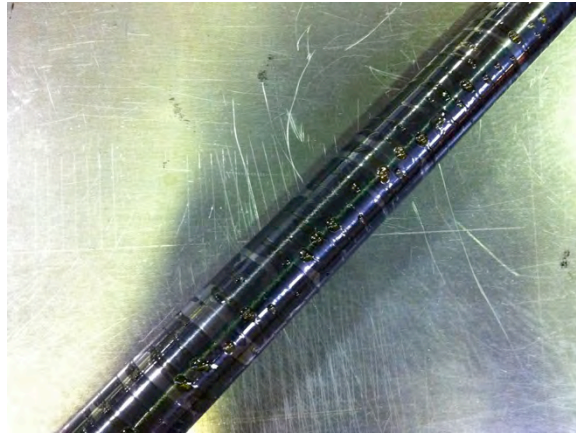
Figure 10.—Photograph of cured hoop-wound tube wrapped in shrink tape.

In order to achieve a wall thickness near 2.5 mm (0.1 in.), hoop-wound tubes were made with nine coverages with a circumferential pattern (each stroke is a coverage with a circumferential pattern). Likewise, the $\pm 45^\circ$ tubes were made with four helical pattern coverages (each coverage is a ± 0 layer in a helical pattern). A helical pattern of five was used in $\pm 45^\circ$ tubes—meaning there are five rhombic patterns around the circumference of the tube. After the layers were wound, Dunstone 220R brand shrink-tape (Charlotte, NC) was circumferentially wound onto the parts with a 50 percent overlap. Following the application of shrink-tape, the parts were placed stationary in an oven and cured at 143 °C (290 °F) for 2 hr. A photograph of a cured part, prior to removing the shrink tape, is shown in Figure 10.

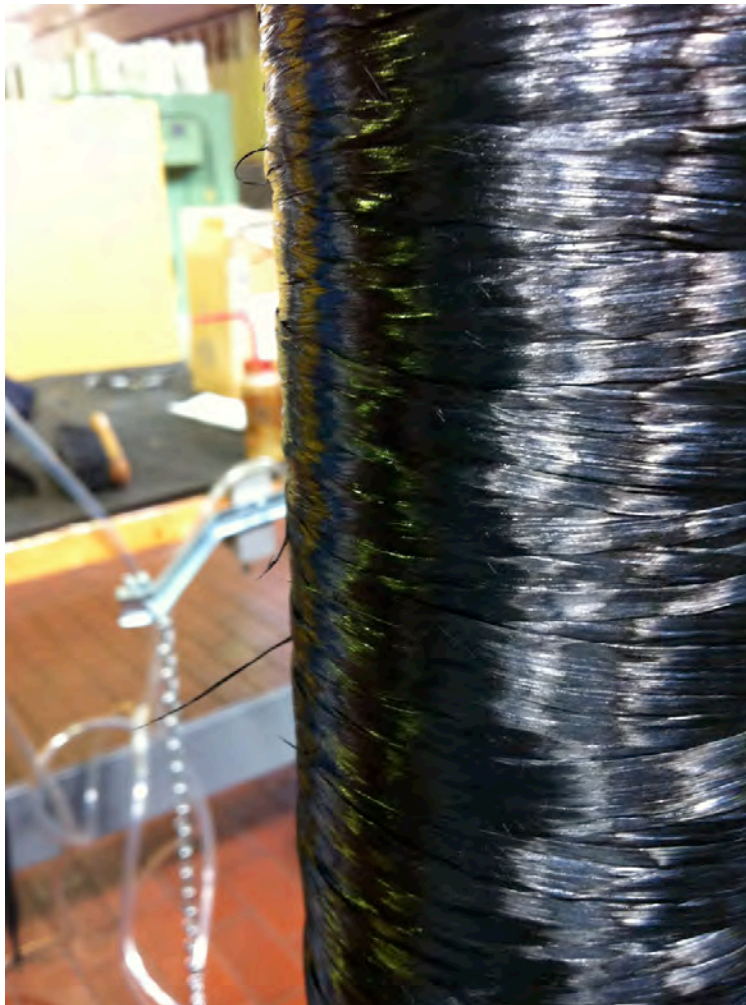
Figure 15.—Open ended fibers.

This section summarizes the winding characteristics of a preliminary batch of coated carbon/epoxy towpreg received on June 13, 2013. The outermost tow was marked clearly and seemed to unspool without any problem at the beginning of the winding process. But after a few passes, it was realized that the tow was not unspooling freely. When the process was stopped and the spool was taken out of the winder, it was seen that the outermost fiber could not unspool freely due to the restriction of the fibers that are crossing over it, as shown in Figure 14. As the outermost tow was pulled during winding, it cut the fibers that are crossing over it causing the occurrence of open-ended fibers as seen in Figure 15. This problem became more severe as the tow was allowed to cut more fibers and the number of the open-ended fibers accumulated. The problem was solved by manually cutting all the fibers that were crossing over the outermost tow, and by removing all of the open-ended fibers. This same behavior was also observed during unwinding of the spool during deposition of the nanofiber and was likely more severe in the modified tow due to rewinding. Performing the nanofiber deposition in line with the resin impregnation process would reduce or eliminate this problem.

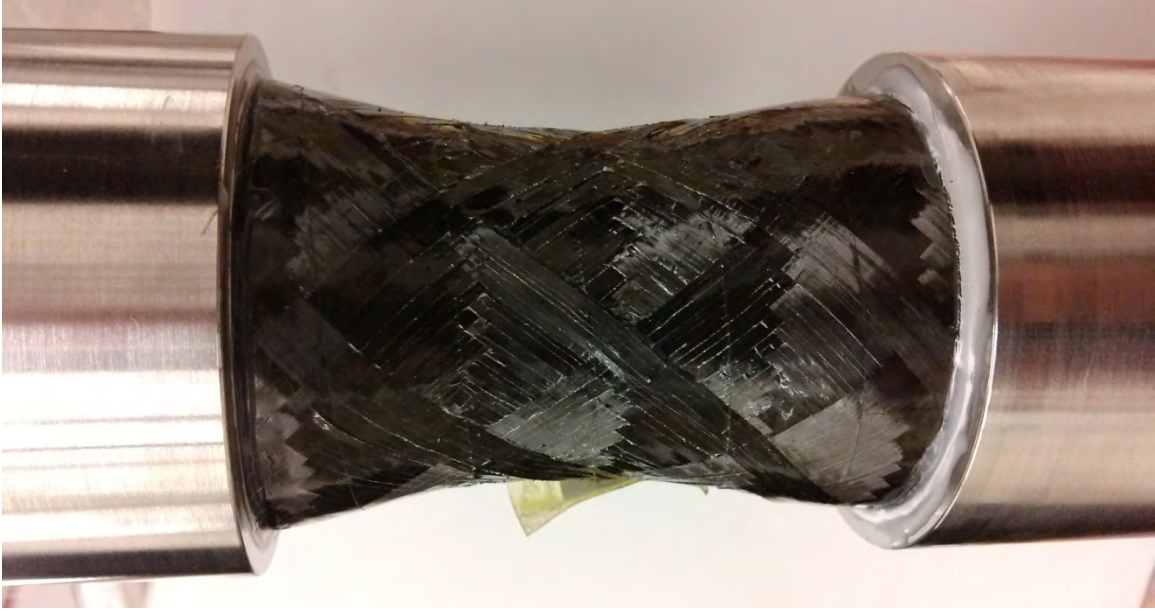
Figure 23.—Failed ± 45 tension specimen still mounted in test machine.

The $\pm 45^\circ$ tensile specimens deformed significantly (radial contraction) following the onset of nonlinearity above 8000 lb (35.6 kN) load (Appendix C). Ultimate failure was characterized by a peak in load followed by an extended unloading (negative load/displacement curve slope) resulting from progressive delamination of the tows. The 90° tensile specimens failed at the end cap bond line at relatively low load with no nonlinear deformation as anticipated. Figure 23 shows a $\pm 45^\circ$ tensile specimen after failure, still mounted in the load frame.

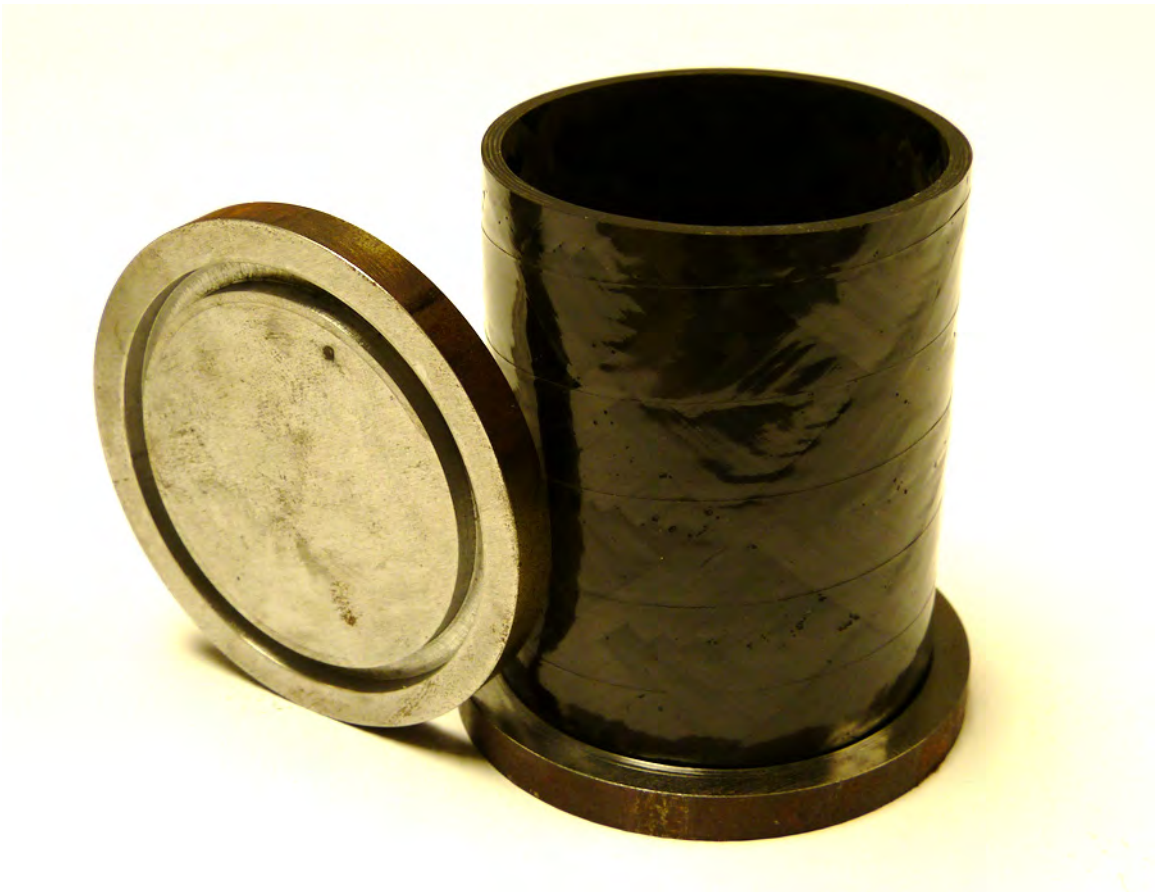
Figure 24.—Compression test end plates and ± 45 specimen.

The ends of the compression coupons were cut flat and parallel using a precision diamond saw. Steel end plates with a shallow channel (0.125 in. deep by 0.125 in. wide with a mean diameter of 1.985 in. or 3.175 mm deep by 3.175 mm wide with a mean diameter of 50.419 mm) were used on the ends of the coupons. The end plates were not bonded to the specimens. The coupon with loose fitting end plates was placed in the test machine between flat compression platens. Figure 24 shows the compression test end plates and a $\pm 45^\circ$ specimen.

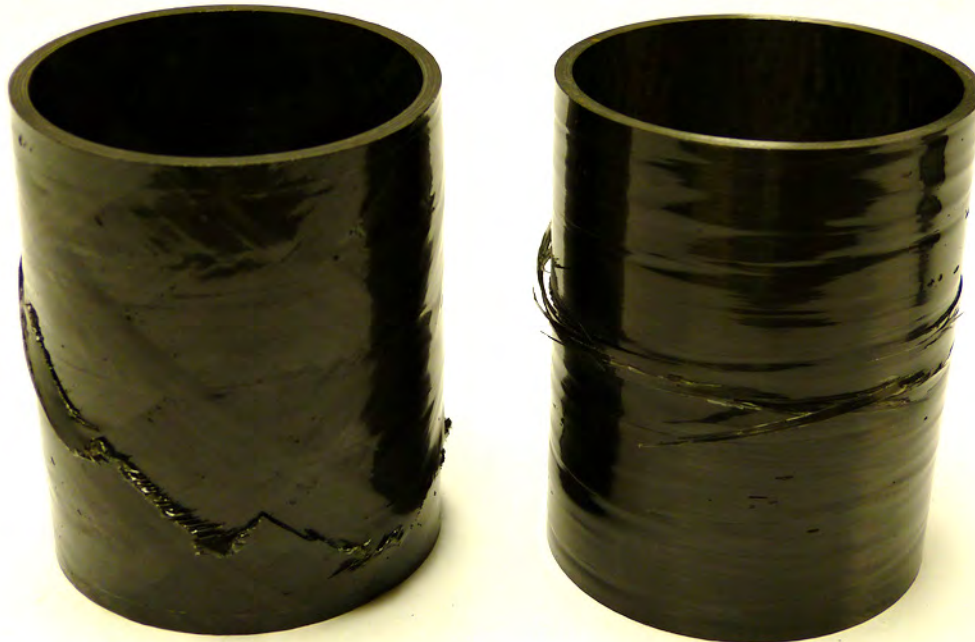
Figure 25.—Examples of compression specimen failures, ± 45 (left) and 90 (right).

The $\pm 45^\circ$ compression specimens show a significant change in stiffness (softening) at higher load that was associated with severe barreling of the tube. The final failure resulted in fractures running along the 45° directions of the fibers, often near one of the end plates. The 90° tubes showed significantly less non-linearity. The compression specimens typically failed toward the middle of the specimen and resulted in broken hoop direction fibers and a local ring of compression damage. Examples of the failure of ± 45 and 90 compression test specimens are shown in Figure 25.
